INDOOR AIR QUALITY ASSESSMENT

**Massachusetts Department of Children and Families
500 Main Street
Hyannis, Massachusetts**

Prepared by:
Massachusetts Department of Public Health
Bureau of Environmental Health
Indoor Air Quality Program
January 2017

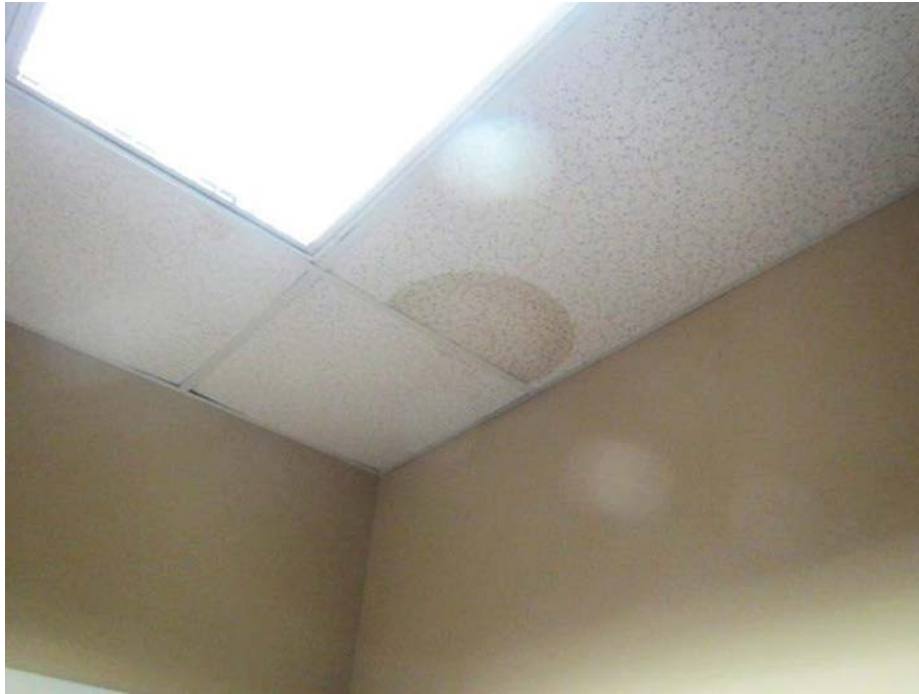
Picture 1

In order for building materials to support mold growth, a source of water exposure is necessary. Water-damaged ceiling tiles were seen in a few areas (Pictures 1 and 2), reportedly due to roof leaks. Water-damaged ceiling tiles indicate leaks from either the roof or plumbing system and can provide a source for mold growth. These tiles should be replaced after a water leak is discovered and repaired.

Water-damaged ceiling tile

1. Continue to work with building management to identify areas of leaks/sources of water damage (e.g., condensation issues above ceiling tiles) for repair/corrective actions. Replace any water-damaged ceiling tiles.
2. A professional flooding restoration/remediation specialist should be consulted to evaluate water-damaged building materials above ceiling tiles for proper cleanup/removal. Coordinate remediation activities and develop a plan specifically designed for the conditions at the DCF.
3. Remediation activities should be conducted in a manner consistent with recommendations found in "Mold Remediation in Schools and Commercial Buildings" published by the US Environmental Protection Agency (US EPA, 2008) and MDPH guidelines "Guidance Concerning Remediation and Prevention of Mold Growth and Water Damage in Public Schools/Buildings to Maintain Air Quality" attached as Appendix A.

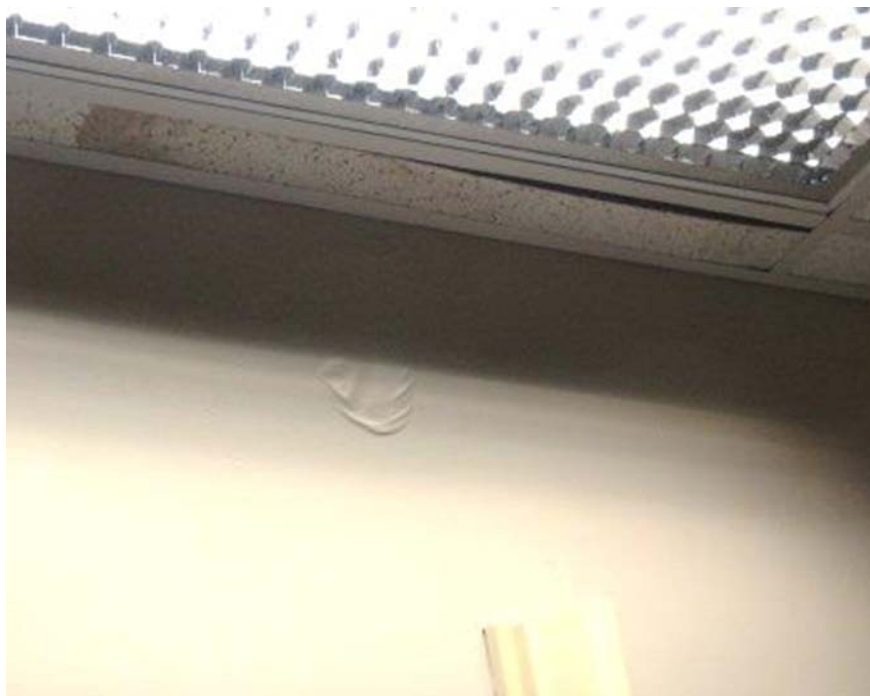
Picture 2

Water-damaged ceiling tile and sloughing paint in ladies restroom

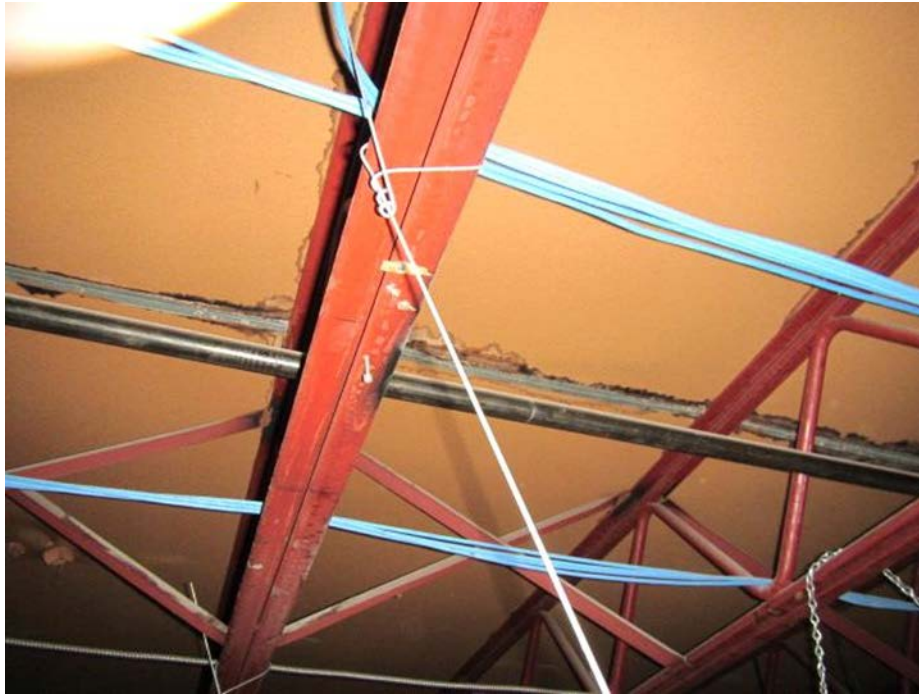
Picture 3

BEH/IAQ staff examined several areas of concern, including the ceiling plenum (above ceiling tiles) and found water damage on wooden beams and ceiling panels above the Screening and Adoption Units (Pictures 3 and 4). As shown in Picture 4, light-colored discoloration of water-damaged building materials was observed above the Adoption Unit, which may be mold growth. No active/current leaks were reported/observed in these areas; therefore the age of this water damage could not be determined.

Water-damaged ceiling panels above suspended ceiling

The US Environmental Protection Agency (US EPA) and the American Conference of Governmental Industrial Hygienists (ACGIH) recommends that porous materials (e.g., wallboard, carpeting, ceiling tiles) be dried with fans and heating within 24 to 48 hours of becoming wet (US EPA, 2008; ACGIH, 1989). If porous materials are not dried within this time frame, mold growth may occur. Once mold has colonized porous materials, they are difficult to clean and should be removed.

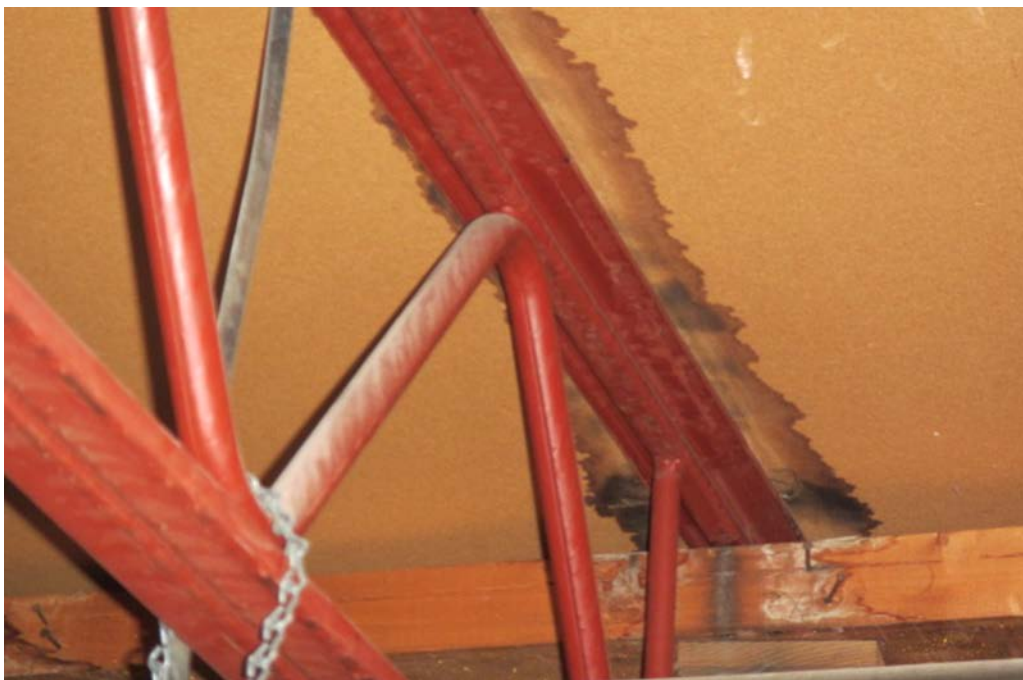
Picture 4

Water-damaged ceiling panels and wooden beams above ceiling tiles, Note light discoloration on beam, which may be mold

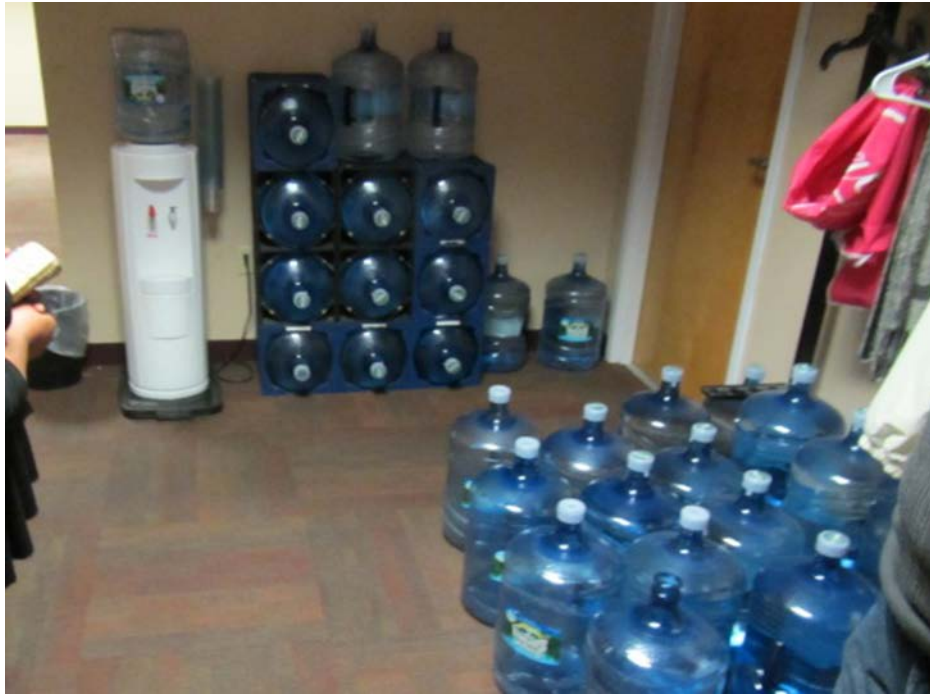
Picture 5

A large number of 5-gallon water cooler bottles are stored on carpeting outside the restrooms (Picture 5). Consideration should be made to place waterproof mats in this area or to

Water storage on carpeting

remove carpet and install non-permeable floor tiles to prevent damage and/or mold growth due to overspill/leakage.

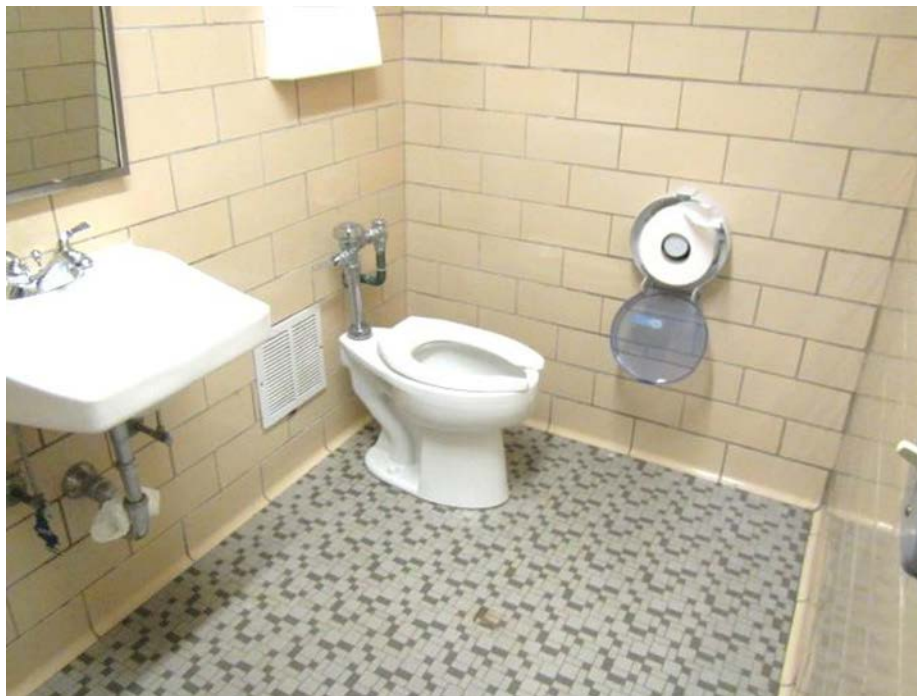
Picture 6

Also noted was a lack of draw from the restroom exhaust vent in the basement. Exhaust ventilation is important in restrooms to remove excess moisture and odors.

Upon flushing of the basement restroom toilet, water was observed leaking from the pipe (Picture 6). Although no porous building materials were in close proximity that could get wet/grow mold, this leak should be repaired.

Leaking toilet and inactive exhaust vent in basement restroom

Location	Carbon Dioxide (ppm)	Carbon Monoxide (ppm)	Temp (°F)	Relative Humidity (%)	PM2.5 (µg/m ³)	Occupants in Room	Windows Openable	Ventilation		Remarks
								Intake	Exhaust	
Basement Restroom							N	N	Y	Exhaust not operating, plumbing leak when toilet flushes

6. Repair basement toilet plumbing to eliminate leaks.
7. Reduce clutter building-wide and increase dust control.
8. Ensure filters for rooftop AHUs are of a pleated variety, MERV dust-spot efficiency 8 or higher, which are adequate in filtering out pollen and mold spores (ASHRAE, 2012). Filters should be changed 2-4 times a year or in accordance with the manufacture's recommendations.
9. Consider installing non-porous floor tiles or use large plastic mats in areas of large volume water storage to prevent damage to carpeting.
10. Refer to resource manual and other related IAQ documents located on the MDPH's website for further building-wide evaluations and advice on maintaining public buildings. These documents are available at <http://mass.gov/dph/iaq>.
